**DOT/FAA/TC-22/35**

# **Small Unmanned Aircraft System for Pavement Inspection: Task 4—Execute the Field Demonstration Plan and Analyze the Collected Data**

November 2022

Final Report

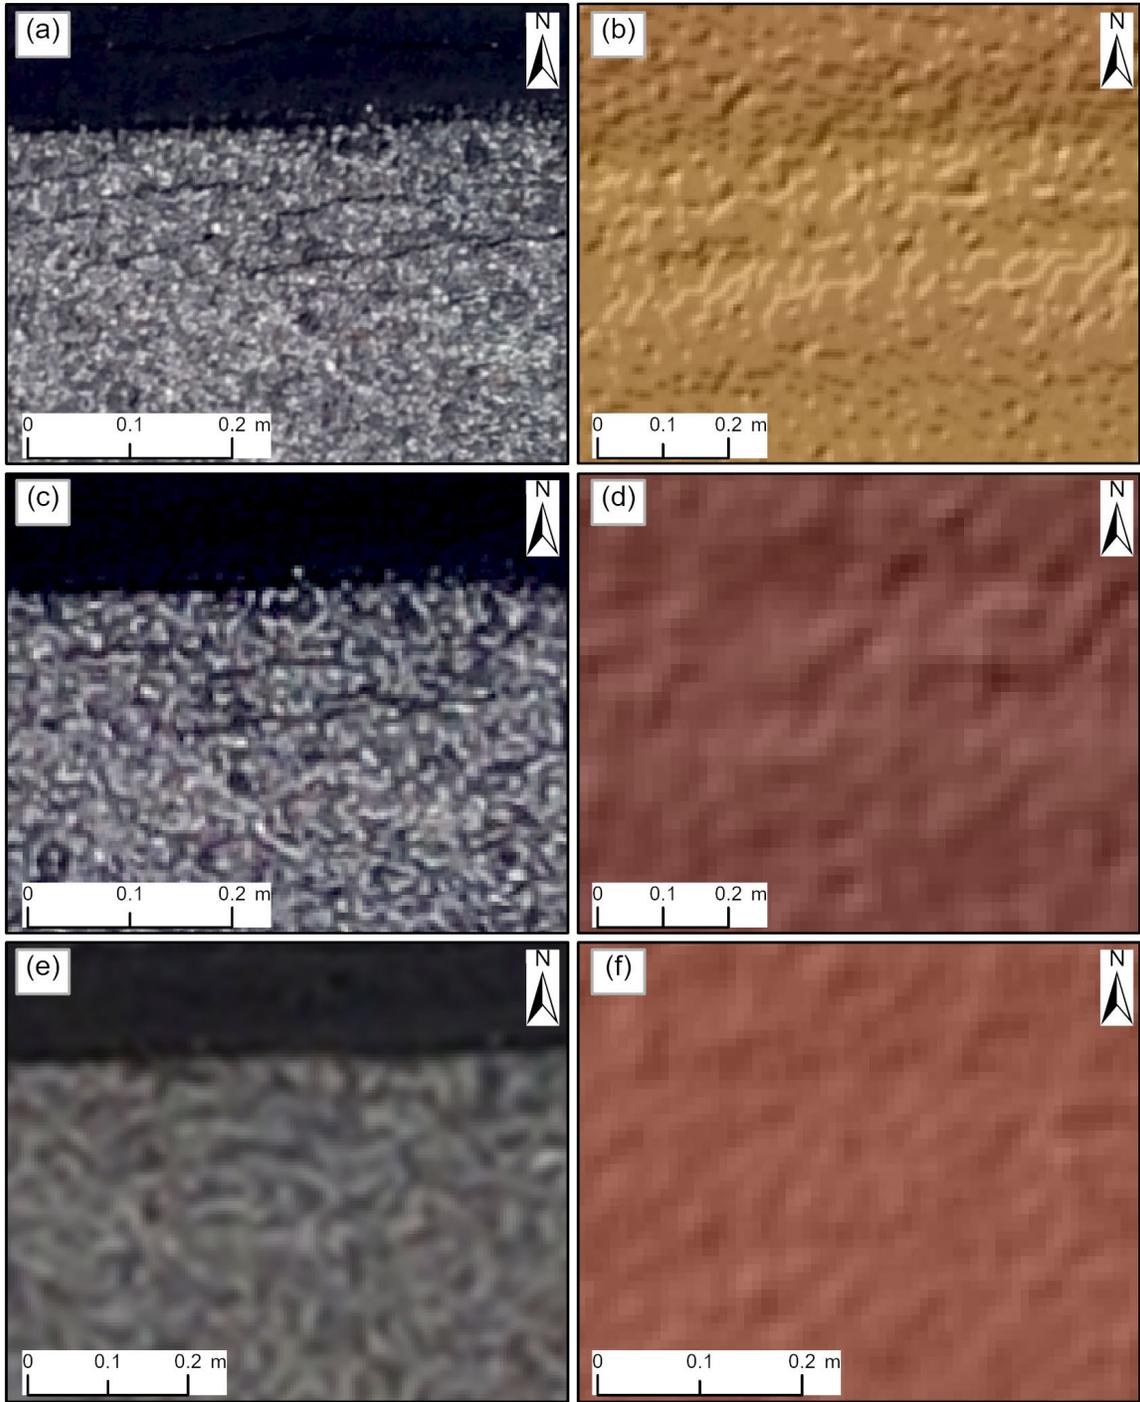
Figure 69. Low-severity Alligator Cracking (a) 1.5-mm/pix Orthophoto, (b) 5.9-mm/pix DEM, (c) 3.5-mm/pix Orthophoto, (d) 14-mm/pix DEM, (e) 4.1-mm/pix Orthophoto, and (f) 16.2-mm/pix DEM

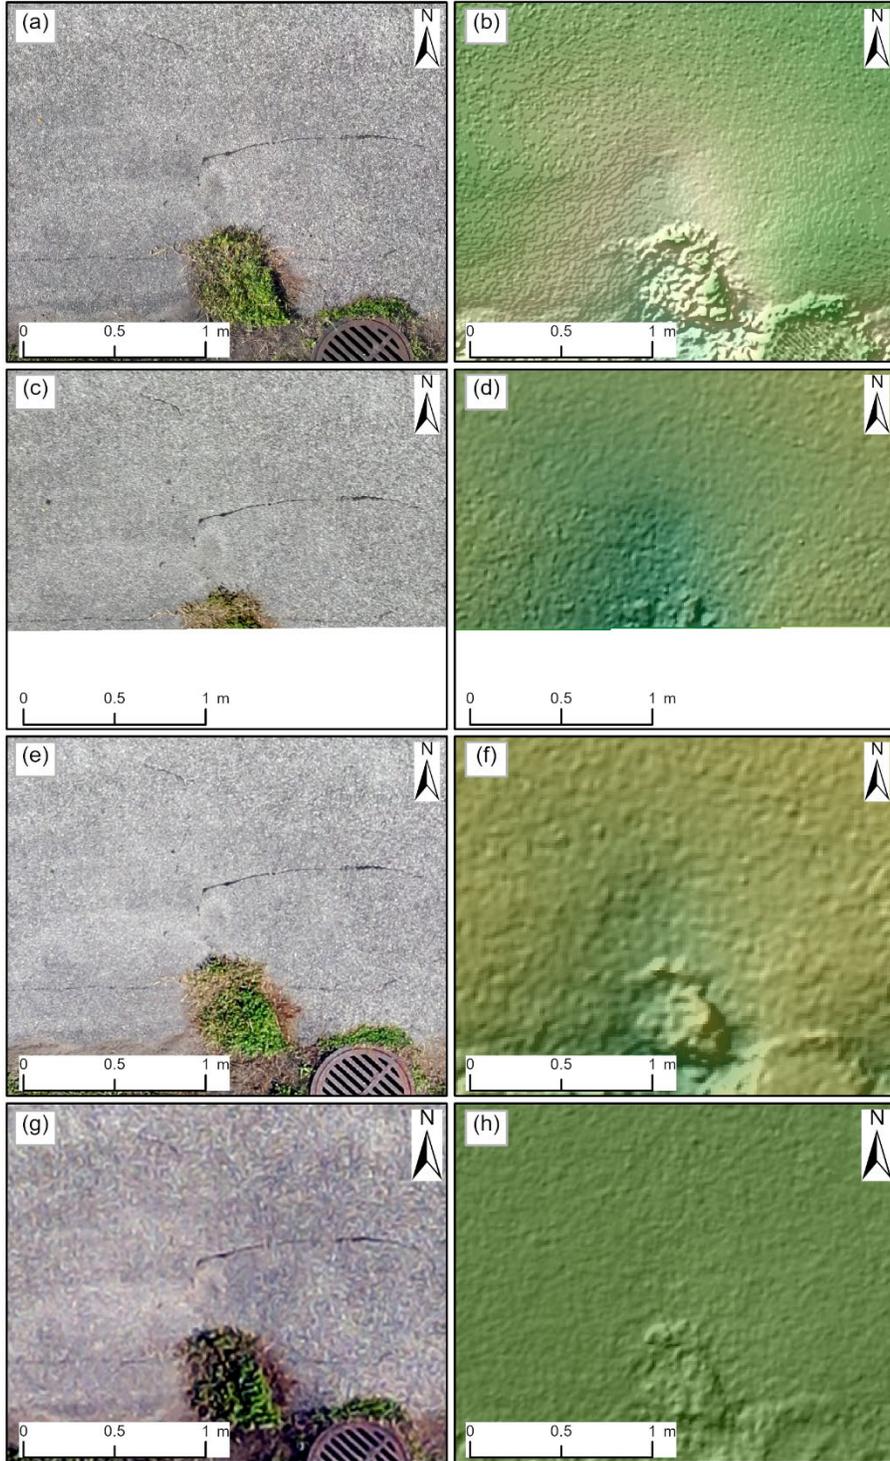
Figure 70. Depression in (a) 1.5-mm/pix Orthophoto, (b) 5.9-mm/pix DEM, (c) 2.2-mm/pix Orthophoto, (d) 8.9-mm/pix DEM, (e) 3.5-mm/pix Orthophoto, (f) 14-mm/pix DEM, (g) 4.1-mm/pix Orthophoto, and (h) 16.2-mm/pix DEM

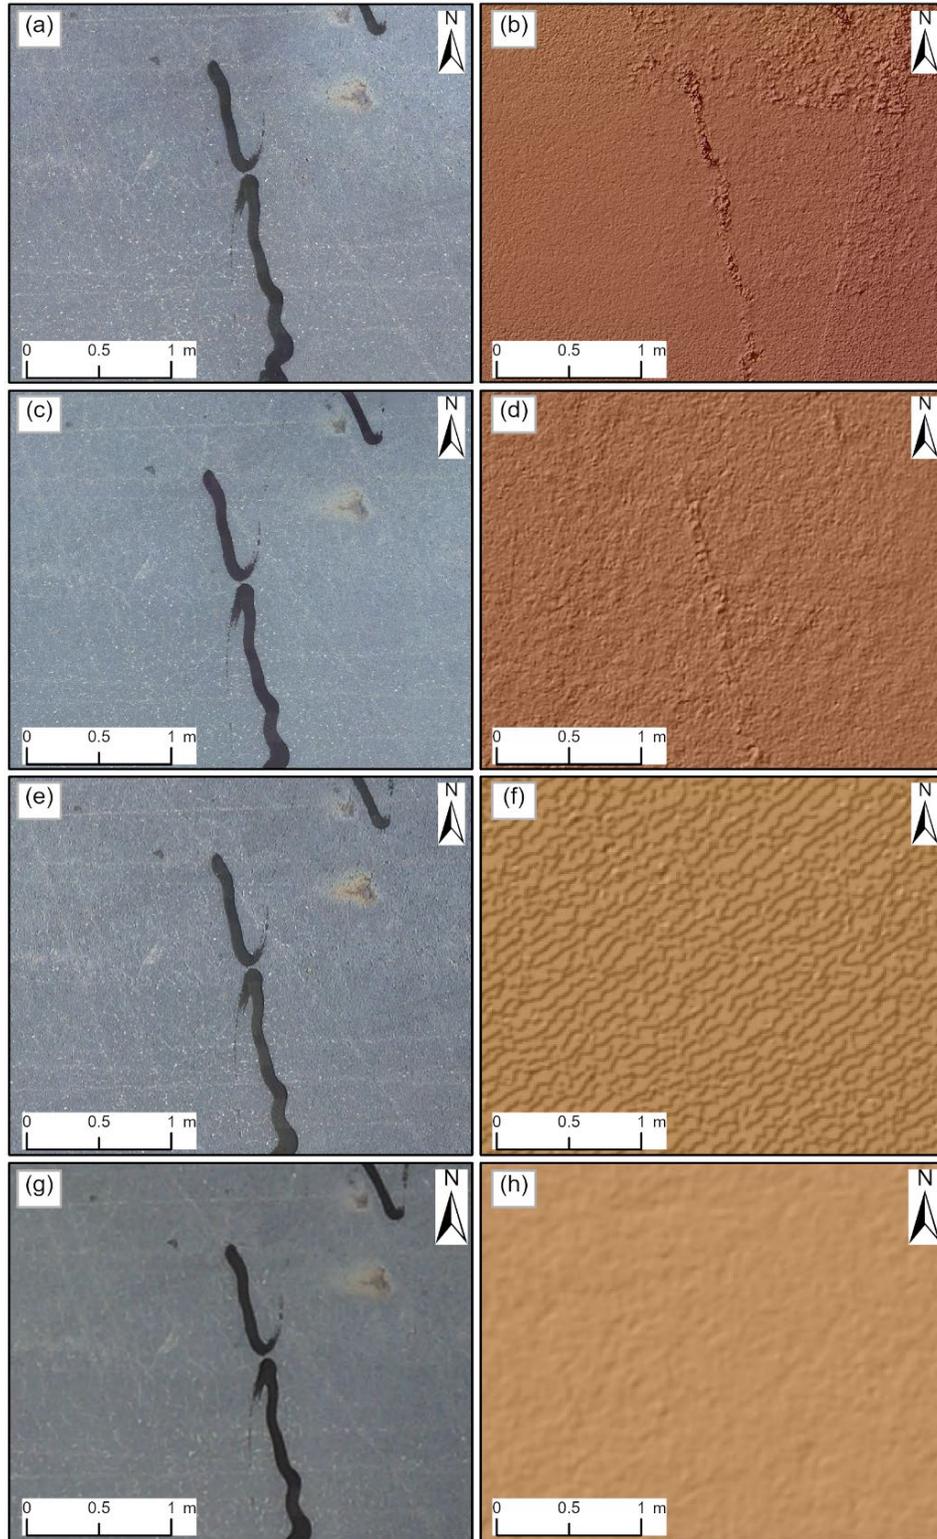
Figure 71. Low-severity L&T Cracks in (a) 0.7-mm/pix Orthophoto, (b) 2.7-mm/pix DEM, (c) 1.5-mm/pix Orthophoto, (d) 5.9-mm/pix DEM, (e) 3.5-mm/pix Orthophoto, (f) 14-mm/pix DEM, (g) 4.1-mm/pix Orthophoto, and (h) 16.2-mm/pix DEM

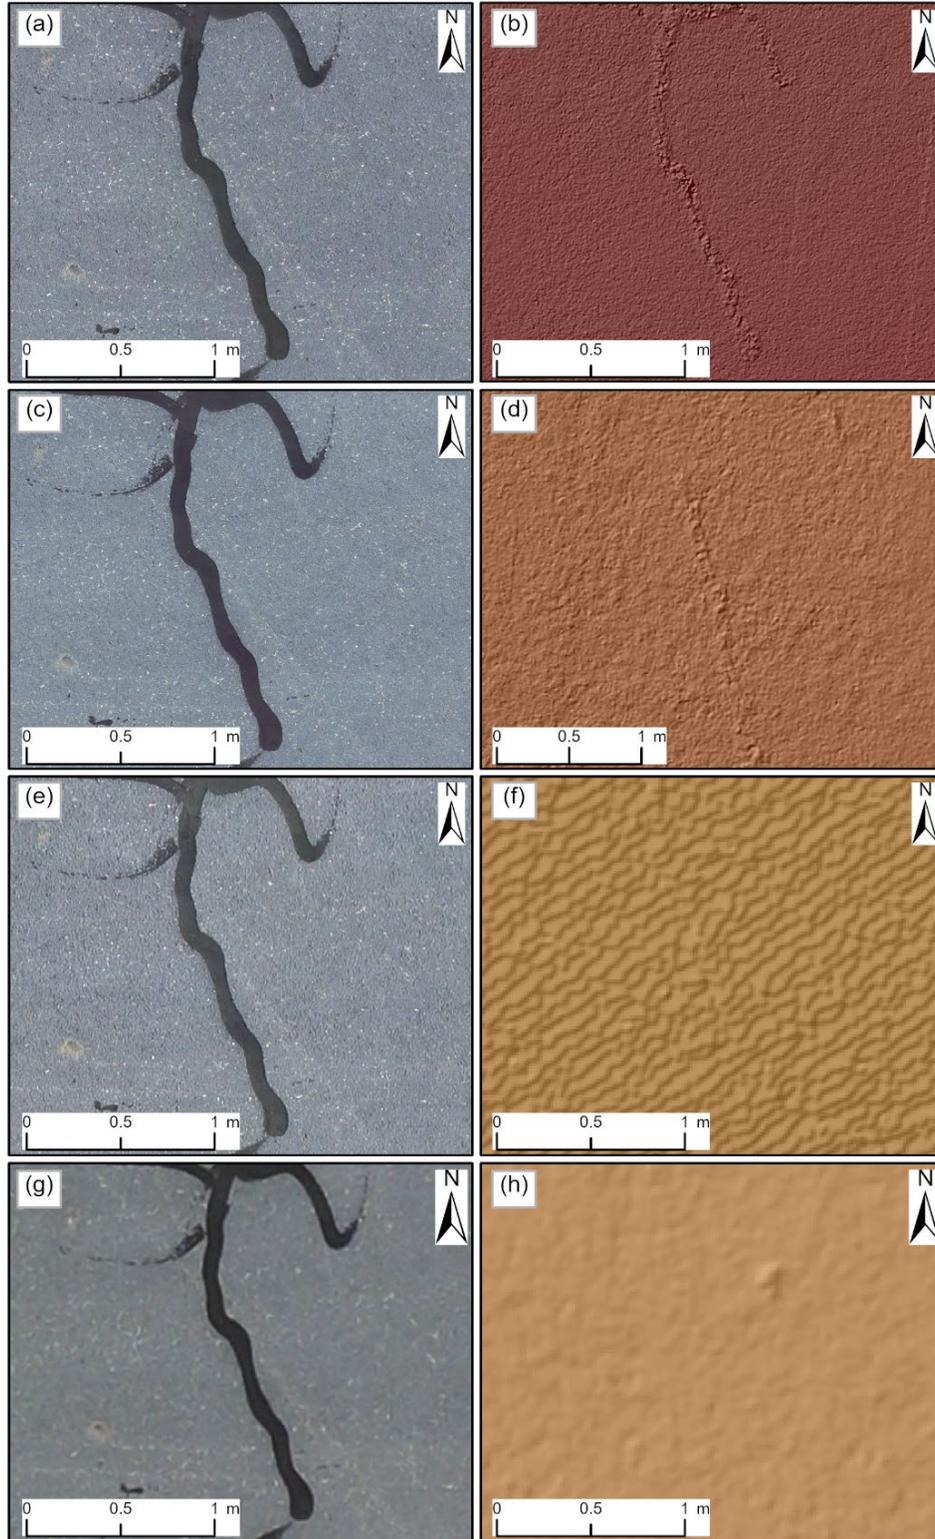
Figure 72. Medium-severity L&T Cracks in (a) 0.7-mm/pix Orthophoto, (b) 2.7-mm/pix DEM, (c) 1.5-mm/pix Orthophoto, (d) 5.9-mm/pix DEM, (e) 3.5-mm/pix Orthophoto, (f) 14-mm/pix DEM, (g) 4.1-mm/pix Orthophoto, and (h) 16.2-mm/pix DEM

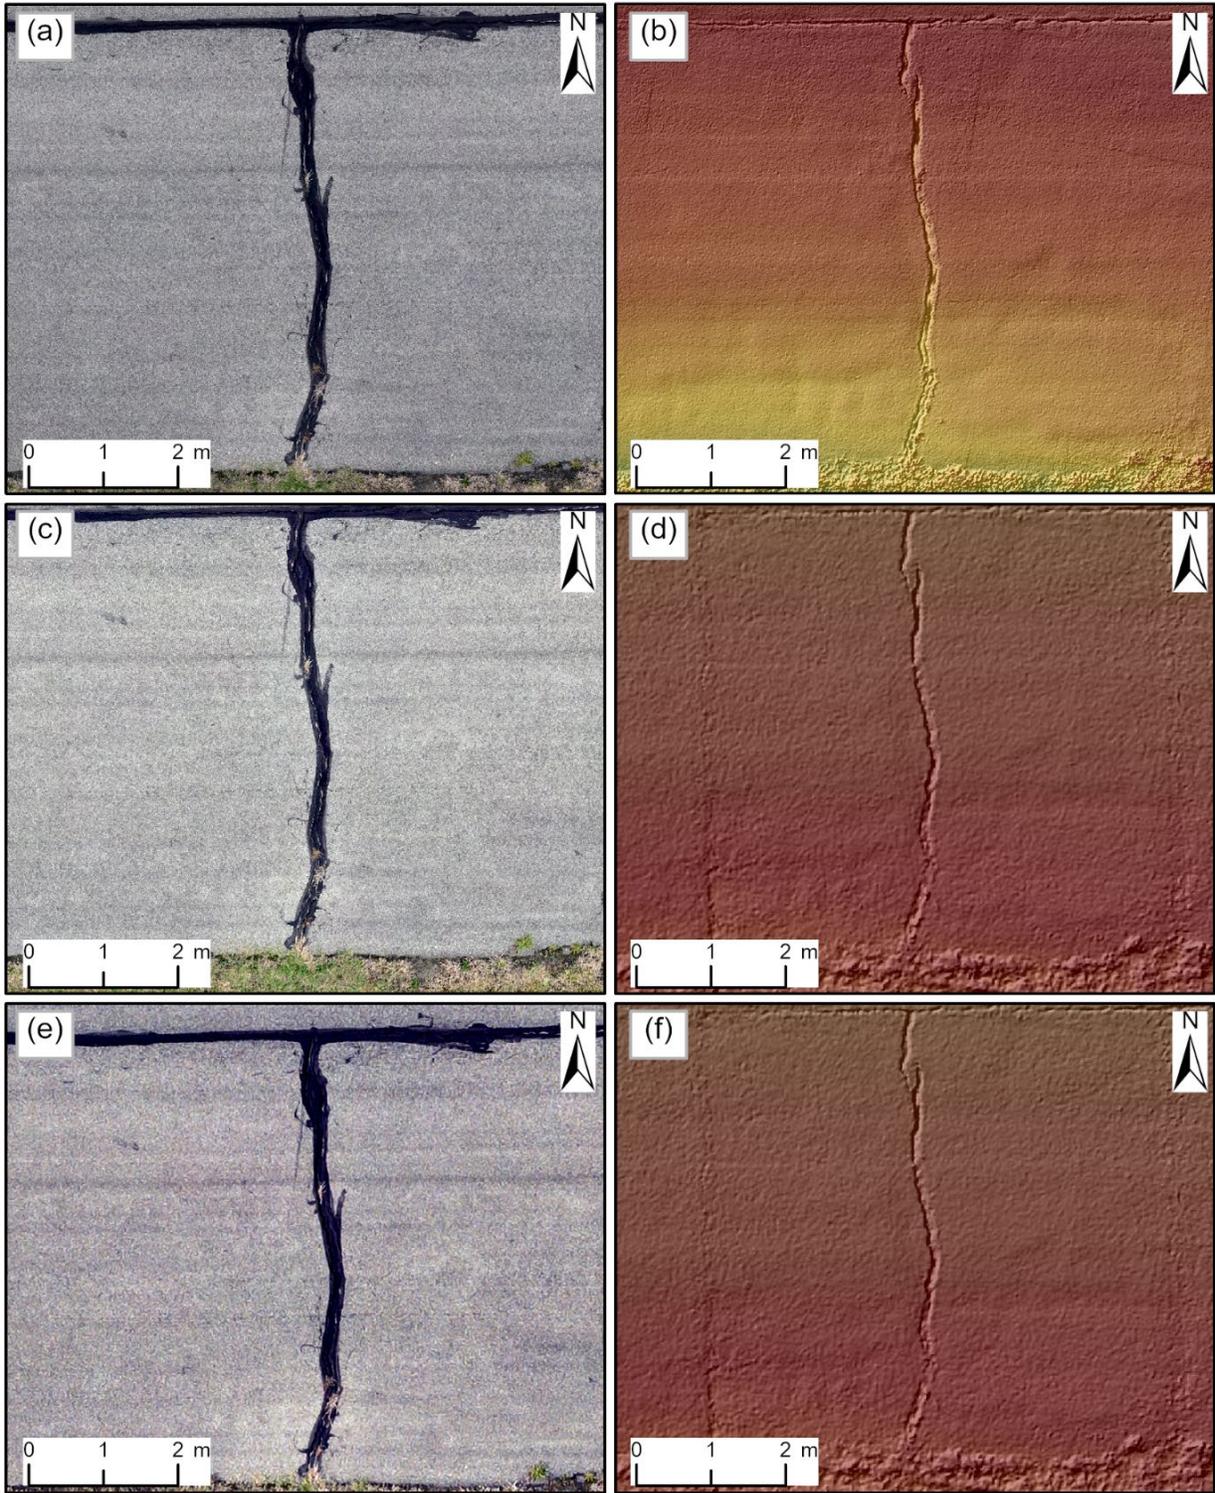
Figure 73. High-severity LTD Cracks in (a) 1.5-mm/pix Orthophoto, (b) 5.9-mm/pix DEM, (c) 3.5-mm/pix Orthophoto, (d) 14-mm/pix DEM, (e) 4.1-mm/pix Orthophoto, and (f) 16.2-mm/pix DEM

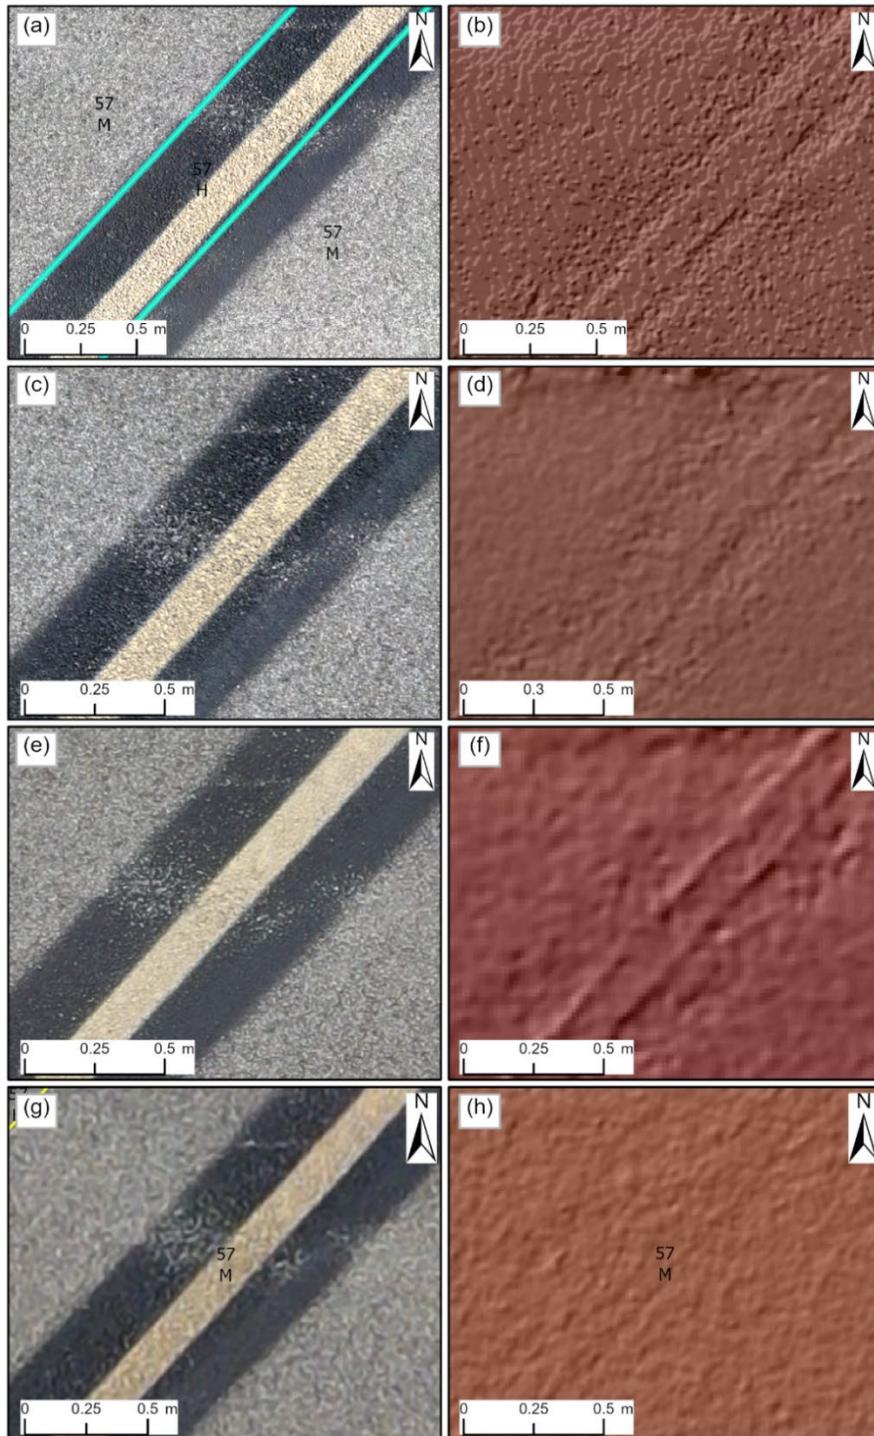
Figure 74. High-severity Weathering in (a) 1.5-mm/pix Orthophoto, (b) 5.9-mm/pix DEM, (c) 2.2-mm/pix Orthophoto, (d) 8.9-mm/pix DEM, (e) 3.5-mm/pix Orthophoto, (f) 14-mm/pix DEM, (g) 4.1-mm/pix Orthophoto, and (h) 16.2-mm/pix DEM

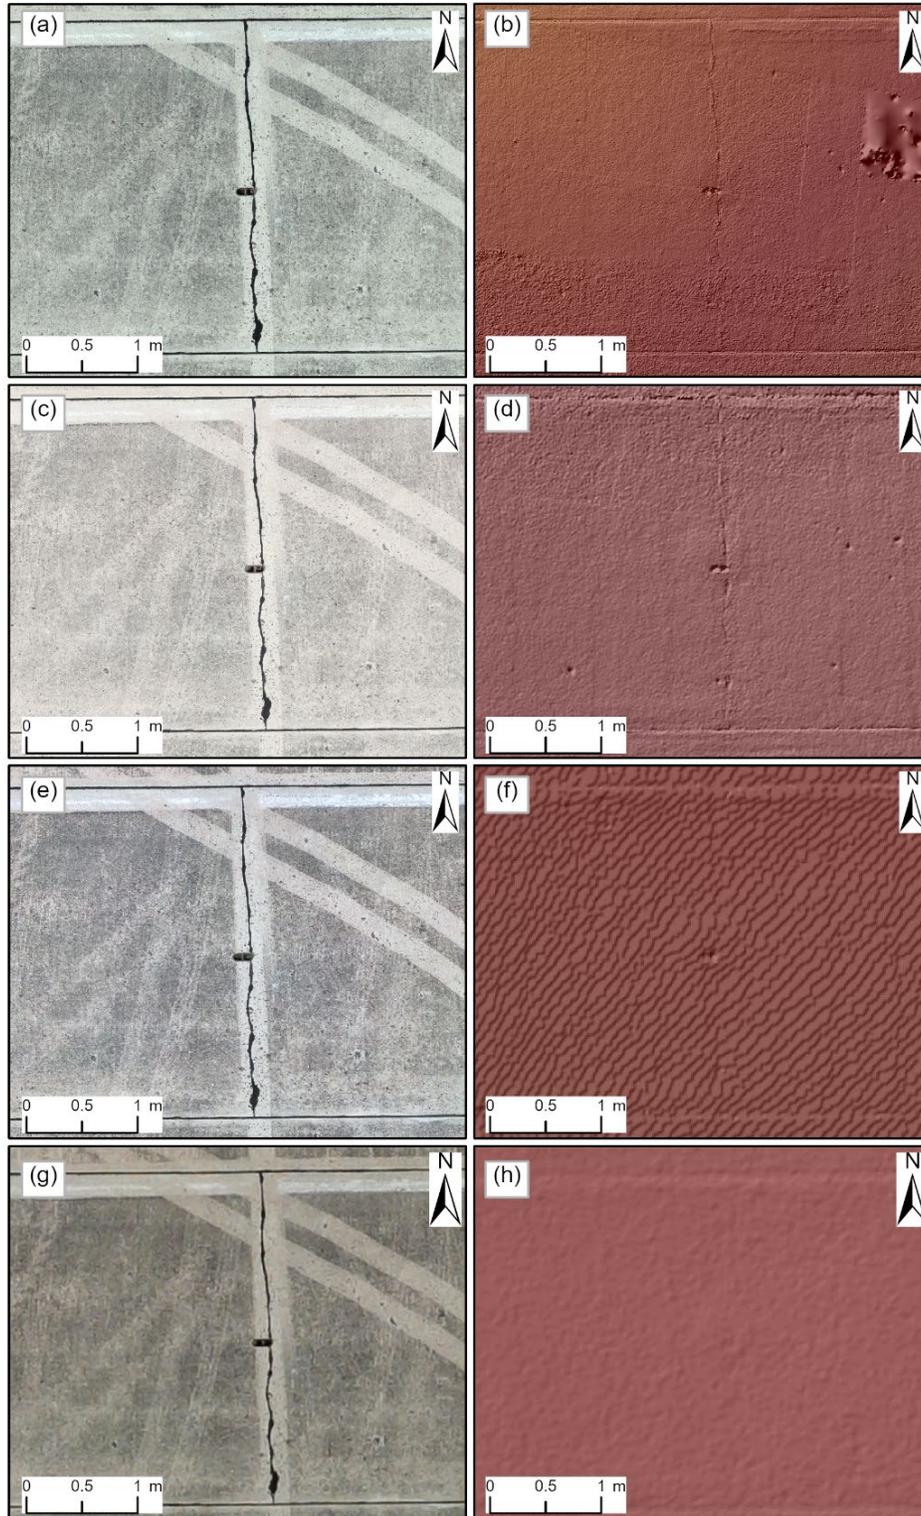
Figure 75. Low-severity LTD Cracks in (a) 0.7-mm/pix Orthophoto, (b) 2.7-mm/pix DEM, (c) 1.5-mm/pix Orthophoto, (d) 5.9-mm/pix DEM, (e) 3.5-mm/pix Orthophoto, (f) 14-mm/pix DEM, (g) 4.1-mm/pix Orthophoto, and (h) 16.2-mm/pix DEM

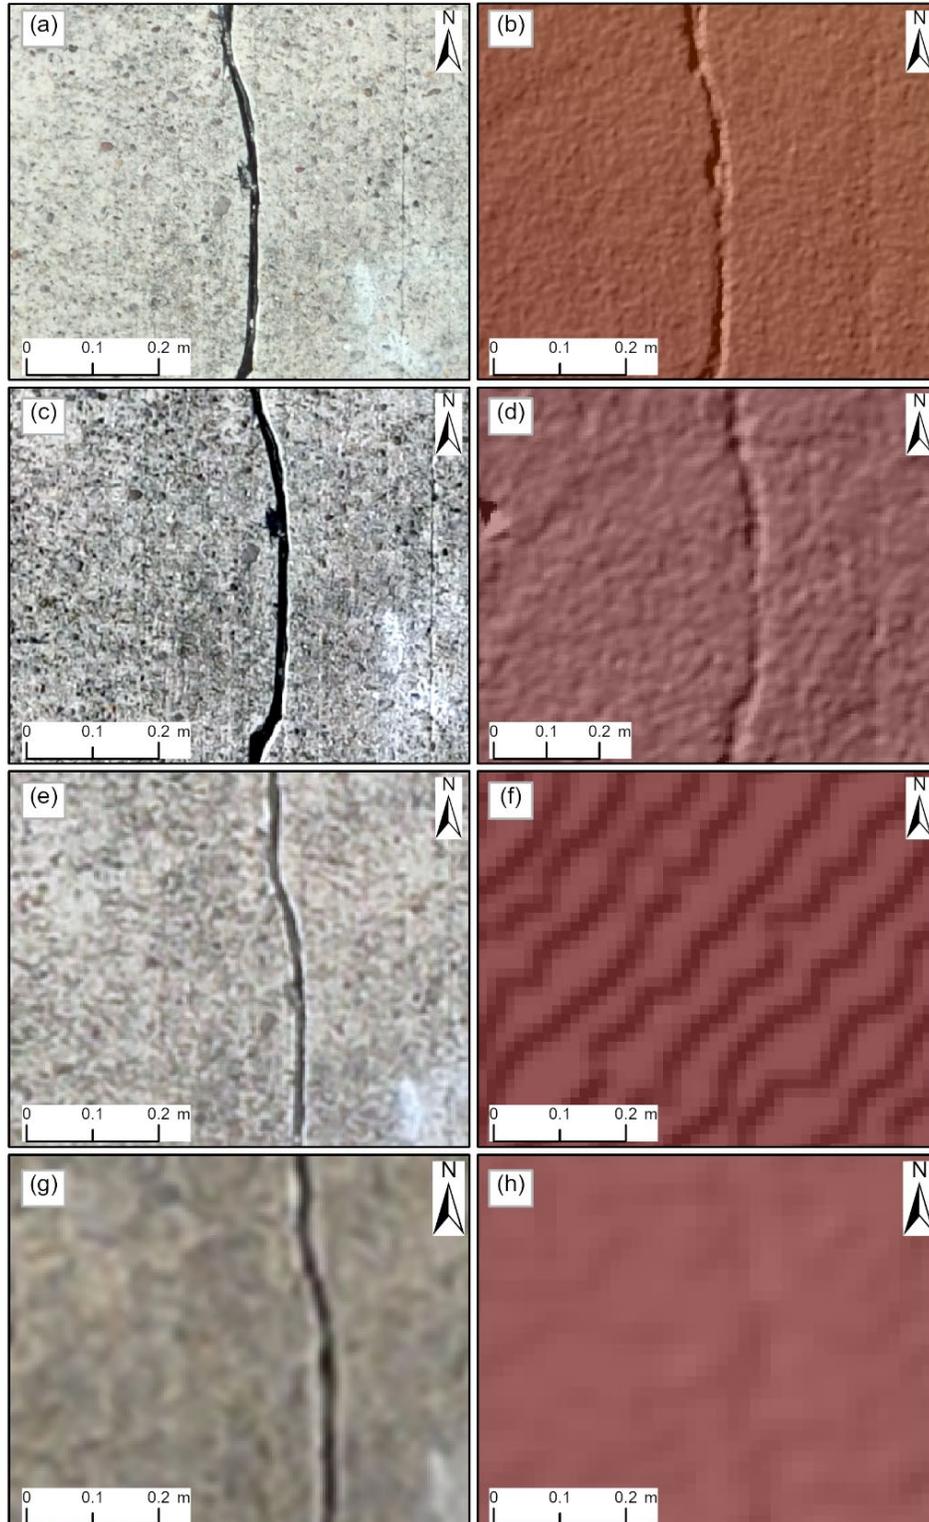
Figure 76. Medium-severity LTD Cracks in (a) 0.7-mm/pix Orthophoto, (b) 2.7-mm/pix DEM, (c) 1.5-mm/pix Orthophoto, (d) 5.9-mm/pix DEM, (e) 3.5-mm/pix Orthophoto, (f) 14-mm/pix DEM, (g) 4.1-mm/pix Orthophoto, and (h) 16.2-mm/pix DEM

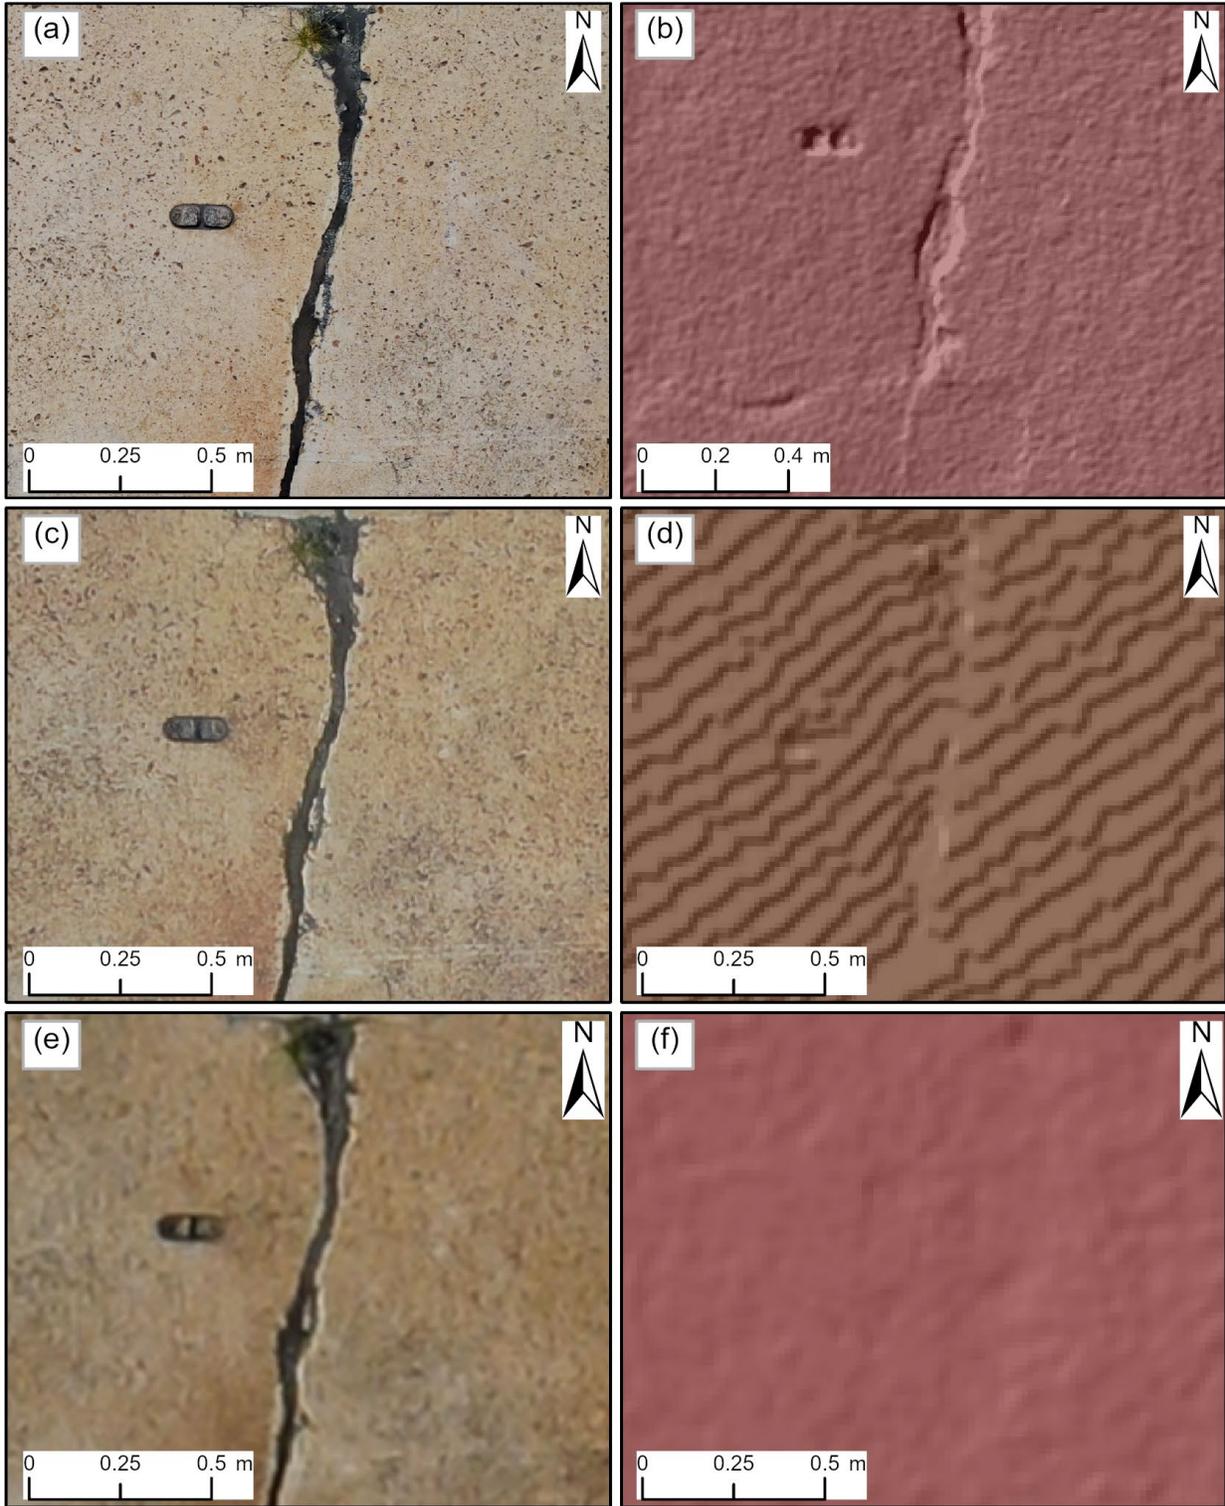
Figure 77. High-severity LTD Cracks in (a) 1.5-mm/pix Orthophoto, (b) 5.9-mm/pix DEM, (c) 3.5-mm/pix Orthophoto, (d) 14-mm/pix DEM, (e) 4.1-mm/pix Orthophoto, and (f) 16.2-mm/pix DEM

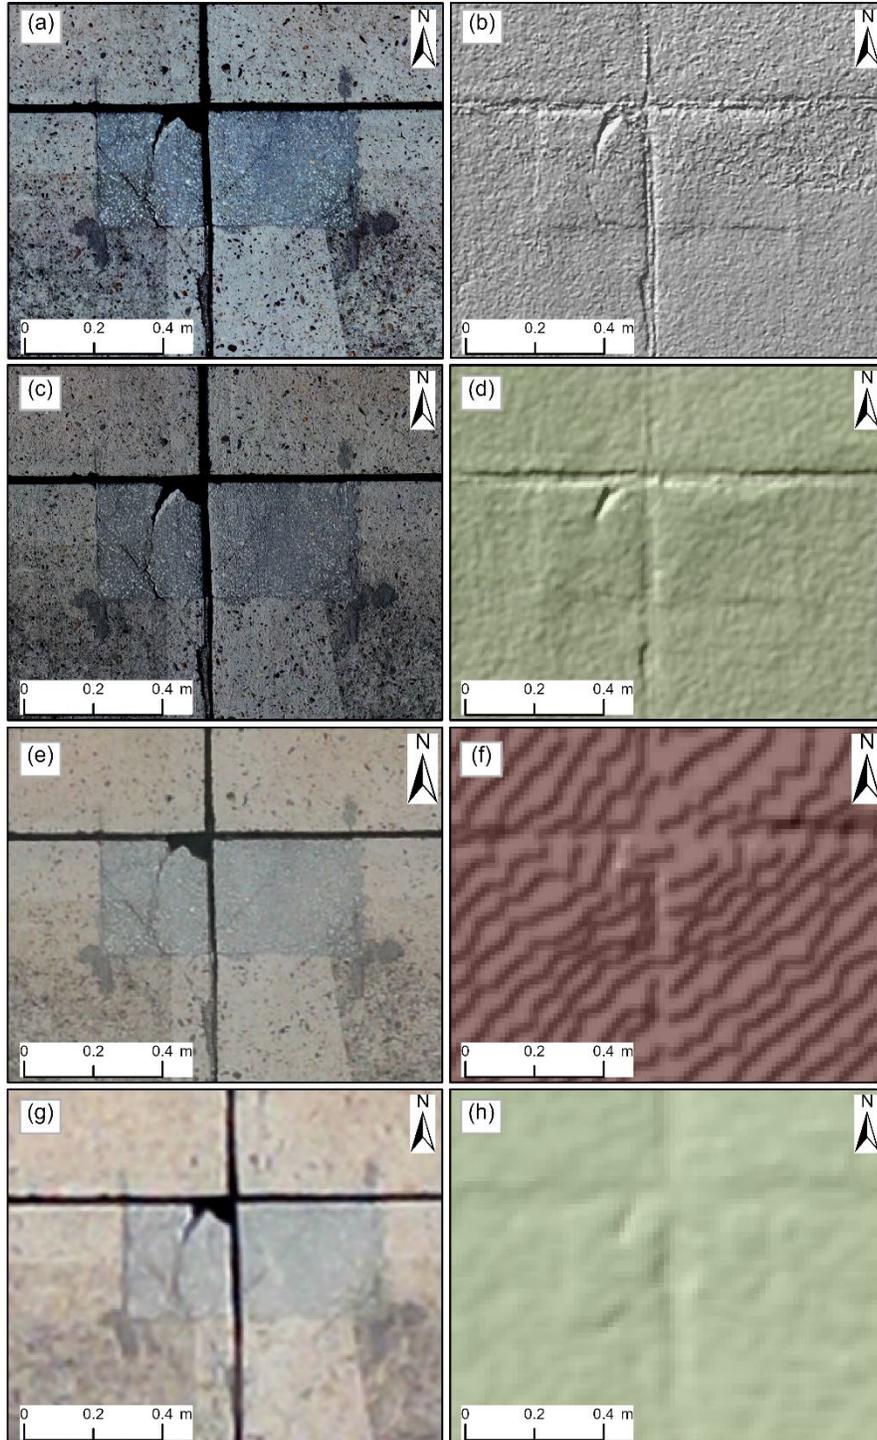
Figure 78. Low-severity Small Patching (L) on Right Quadrant, Medium-severity Small Patching on Left Quadrant, and Low-severity ASR in bottom of the Low-severity Small Patching in (a) 0.7-mm/pix Orthophoto, (b) 2.7-mm/pix DEM, (c) 1.5-mm/pix Orthophoto, (d) 5.9-mm/pix DEM, (e) 3.5-mm/pix Orthophoto, (f) 14-mm/pix DEM, (g) 4.1-mm/pix Orthophoto, and (h) 16.2-mm/pix DEM

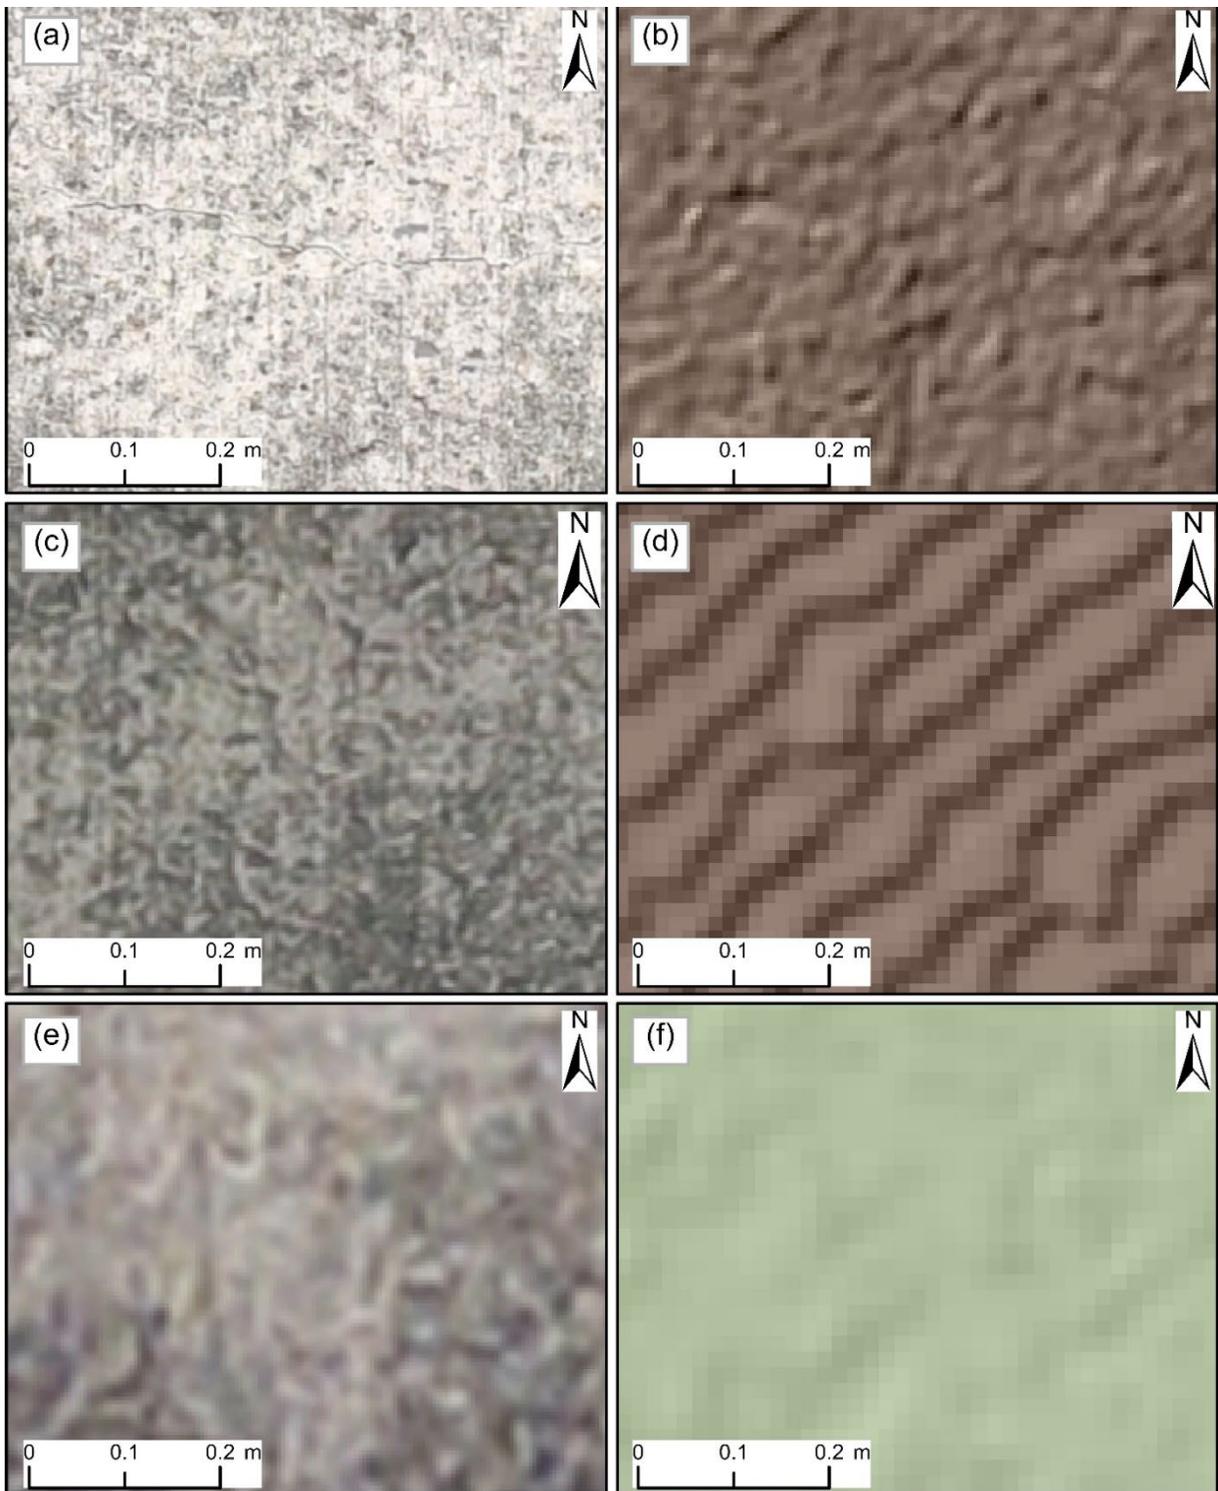
Figure 82. Shrinkage Cracks in (a) 1.5-mm/pix Orthophoto, (b) 5.9-mm/pix DEM, (c) 3.5-mm/pix Orthophoto, (d) 14-mm/pix DEM, (e) 4.1-mm/pix Orthophoto, and (f) 16.2-mm/pix DEM

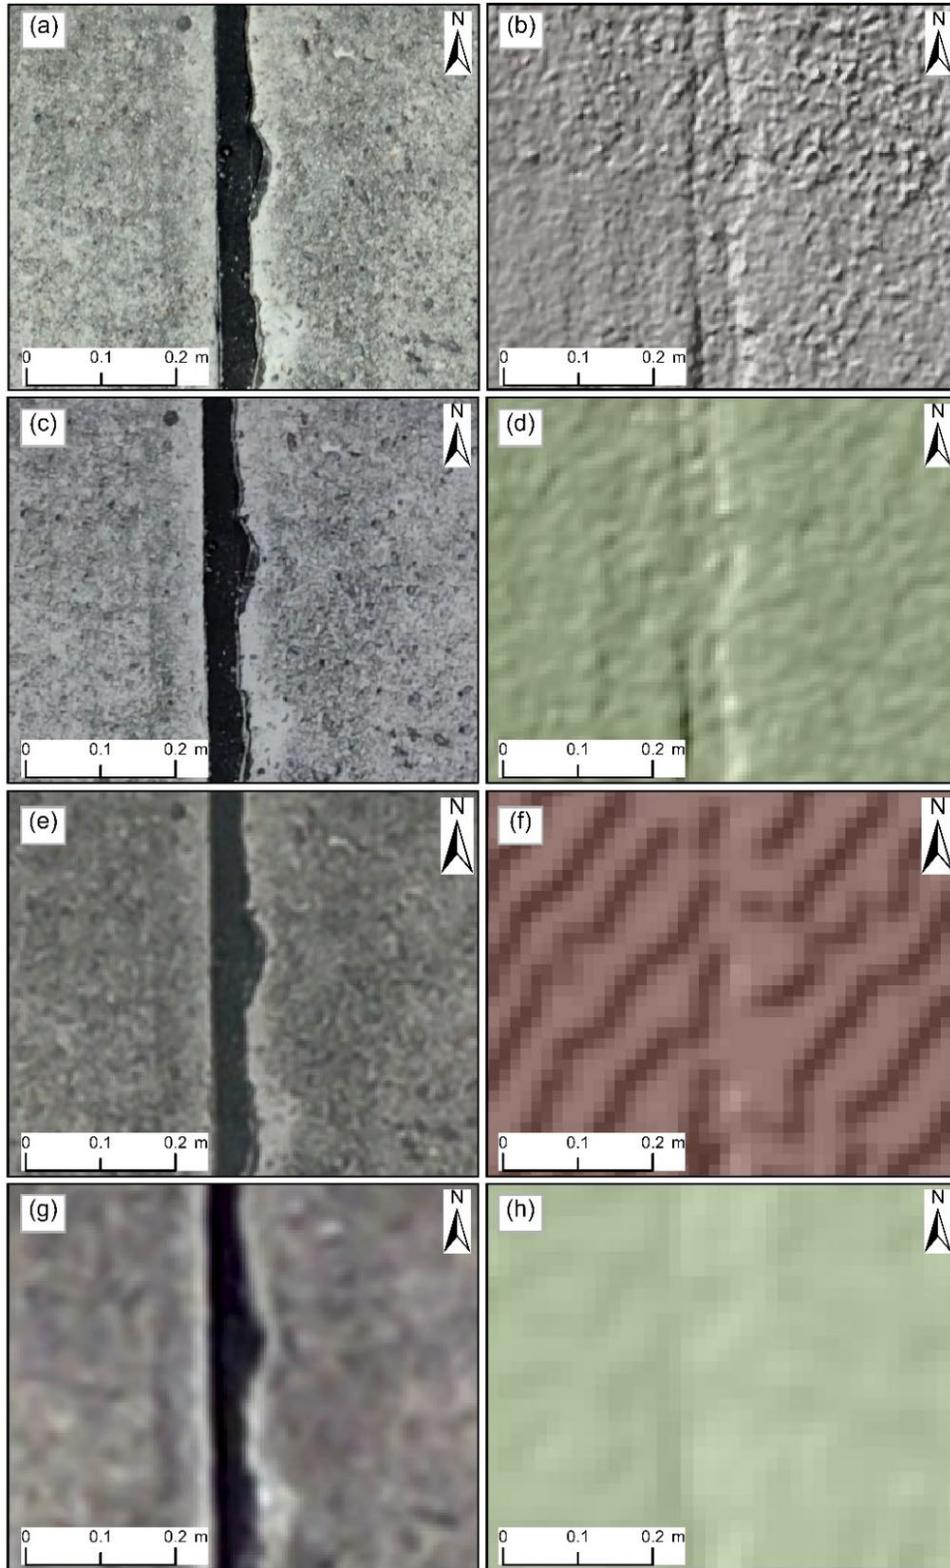
Figure 83. Low-severity Joint Spalling in (a) 0.7-mm/pix Orthophoto, (b) 2.7-mm/pix DEM, (c) 1.5-mm/pix Orthophoto, (d) 5.9-mm/pix DEM, (e) 3.5-mm/pix Orthophoto, (f) 14-mm/pix DEM, (g) 4.1-mm/pix Orthophoto, and (h) 16.2-mm/pix DEM

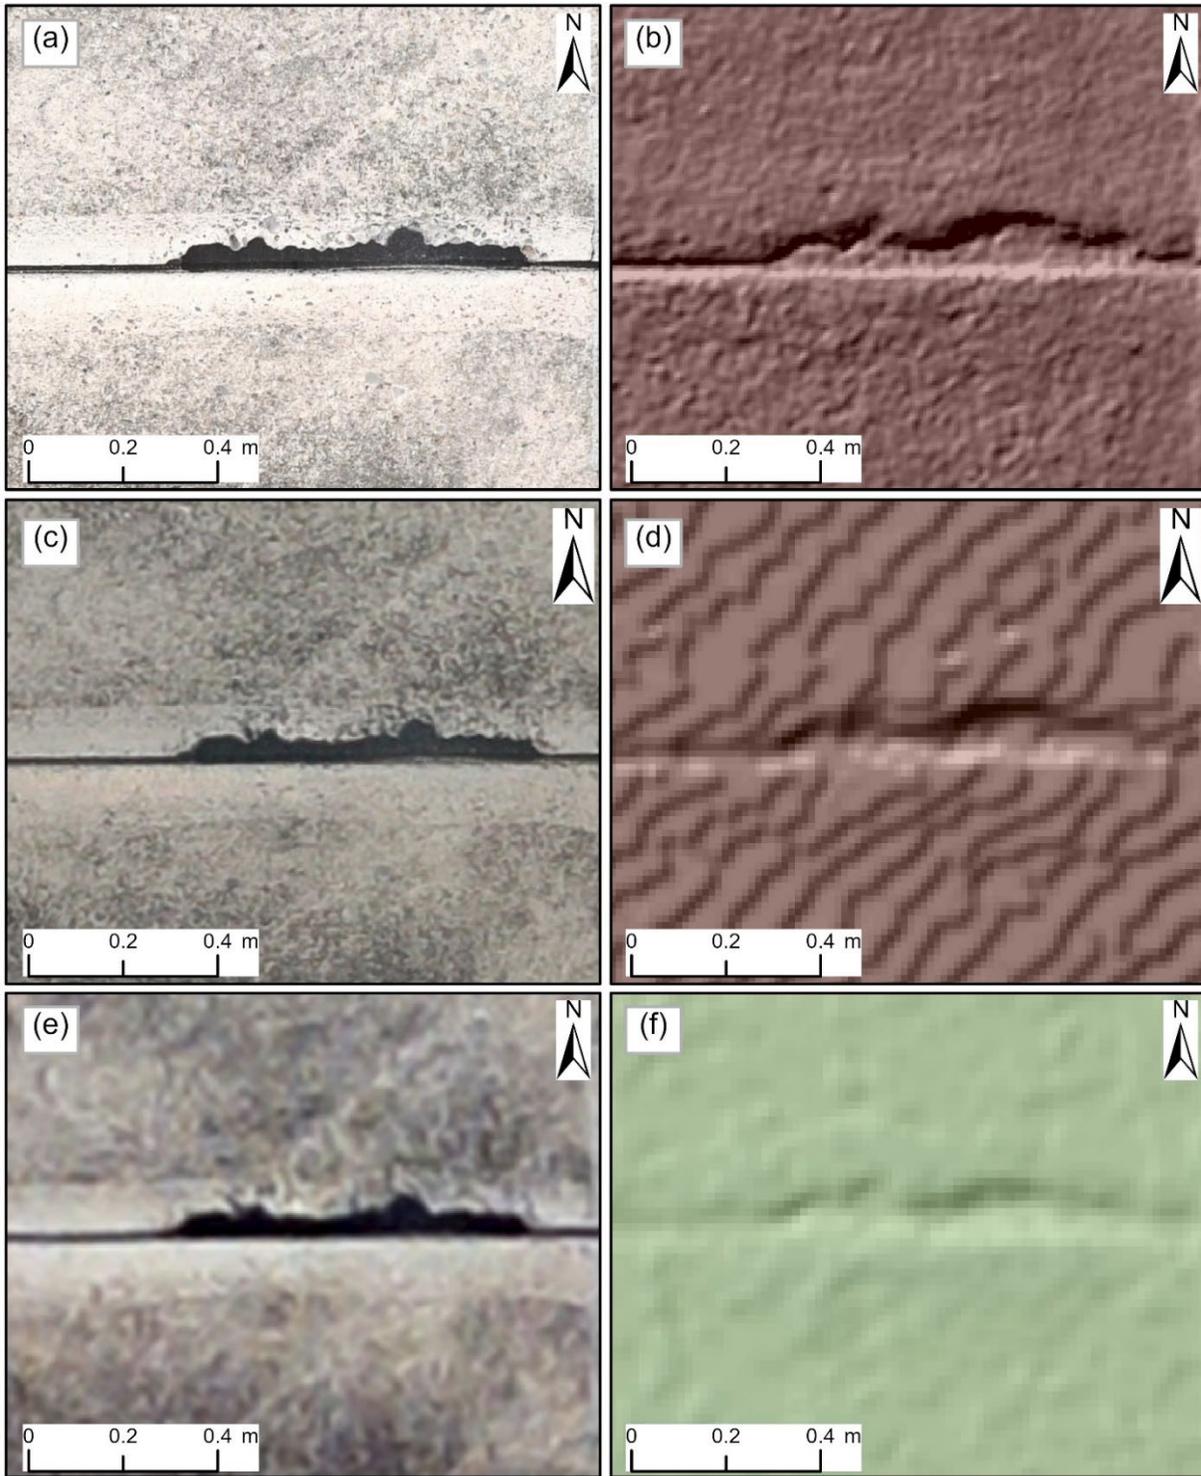
Figure 84. Medium-severity Joint spalling in (a) 1.5-mm/pix Orthophoto, (b) 5.9-mm/pix DEM, (c) 3.5-mm/pix Orthophoto, (d) 14-mm/pix DEM, (e) 4.1-mm/pix Orthophoto, and (f) 16.2-mm/pix DEM
